ATTENTION

Volume Markings on the ARUP Standard Transport Tube

March 4, 2010

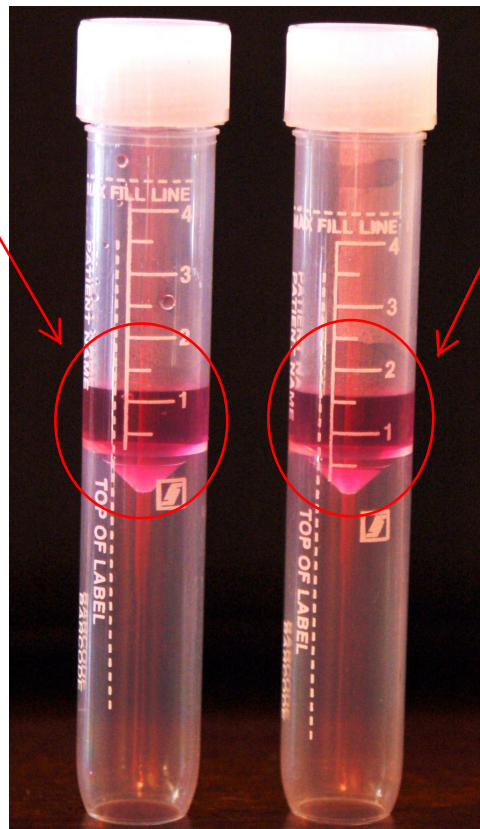
It has recently come to our attention that volume markings on a specific lot number of ARUP Standard Transport Tubes (Supply #15824) were not produced correctly. The picture below demonstrates the problem. Each tube was filled with 1 mL of liquid. The tube on the left has the correct volume markings. The tube on the right shows the volume markings to be 0.5 mL higher than the actual volume. Clients may still use these tubes, but should be aware that the inaccurate markings could result in QNS specimen submissions. To avoid QNS issues, please provide additional specimen volume when possible.

Correct tube markings

Incorrect tube markings

ARUP Laboratories is working with our vendor to correct this problem. The percentage of stock affected is also being investigated. We regret any inconvenience that may have resulted from this situation. Please refer inquiries regarding this letter to ARUP Client Services at (800) 522-2787.
